Press Information

METALOCK REPAIRS PROVIDE SAFE PARAPETS FOR LISTED RAIL BRIDGE AT CODSALL

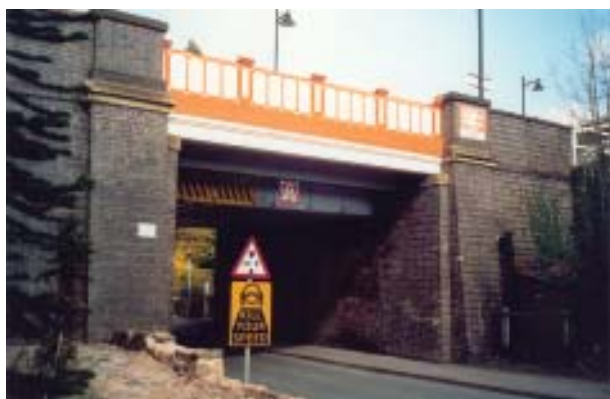
Metallock Engineering provided the answer to the broken cast iron retaining lips by stitching in specially designed 10mm thick steel inserts following dressing to a uniform shape.

The coping fractures were hand dressed and clamped to prevent movement prior to being metallocked back together. The upstand lips were not as simple, as these required specially designed 10mm thick steel inserts to replace the broken areas. Damaged sections were hand dressed to a uniform shape to accept rectangular inserts ranging in length from 250mm to 700mm long with tails on one long edge to assist in location.
