METALOCK IN-SITU MACHINING EXPERTISE EXTENDS LIFE OF CZECH TURBINE COMPRESSOR CASING

To extend the life of the compressor discharge casing of a 160MW gas turbine in the Czech Republic - about 100km north of Prague — Metalock Engineering has recently remachined two rows of stator blade dovetail slots to restore the design dimensions enabling the blades to be properly secured. The alternative was an expensive new casing and the added problem of a long production lead time from the manufacturers.

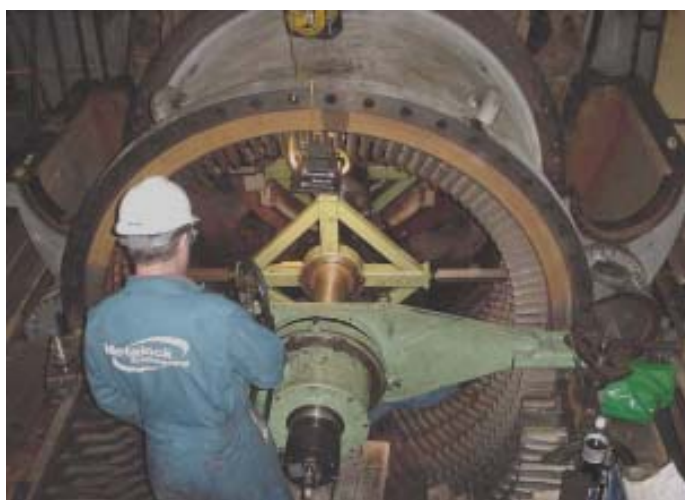
To assure the best results Metalock used one of its heavy duty boring units supported in the horizontal joint face of the casing housing either side of the E1 and E2 grooves with the two casing halves bolted together.

Metalock had no hesitation in accepting the task, knowing that it had the expertise and equipment to cost effectively in-situ remachine the slots in the cast iron casing to the accuracy required. To assure the best results, Metalock used one of its heavy-duty boring units. This was supported in the horizontal joint face of the casing bearing housing either side of the E1 and E2 grooves with the two casing halves bolted together. It took Metalock's team six 12-hour shifts to complete the work which was well within the time and budget allowances.
