Metalock Engineering UK Ltd

Protecting Britain's Heritage

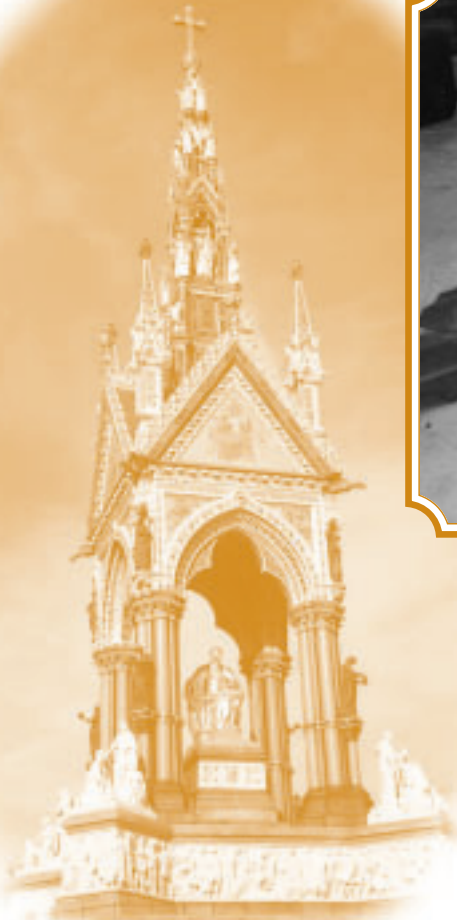
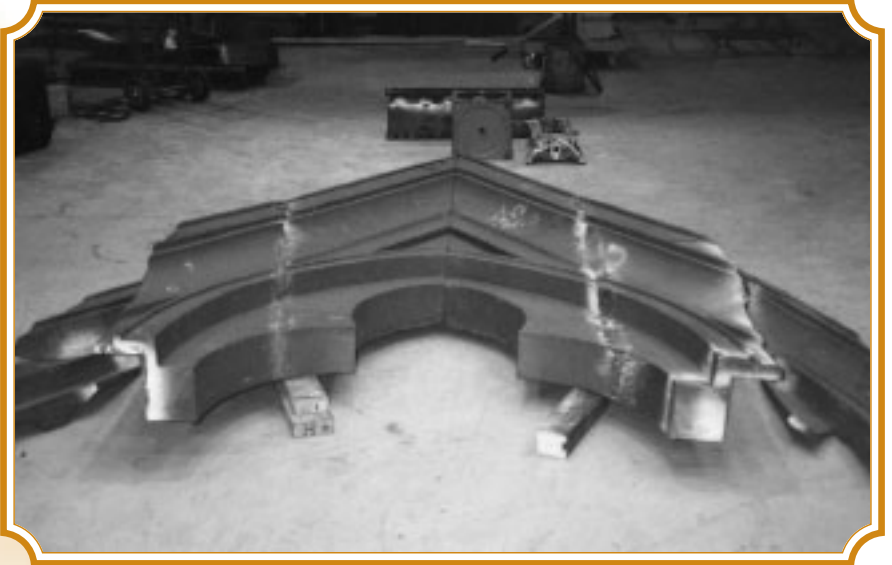
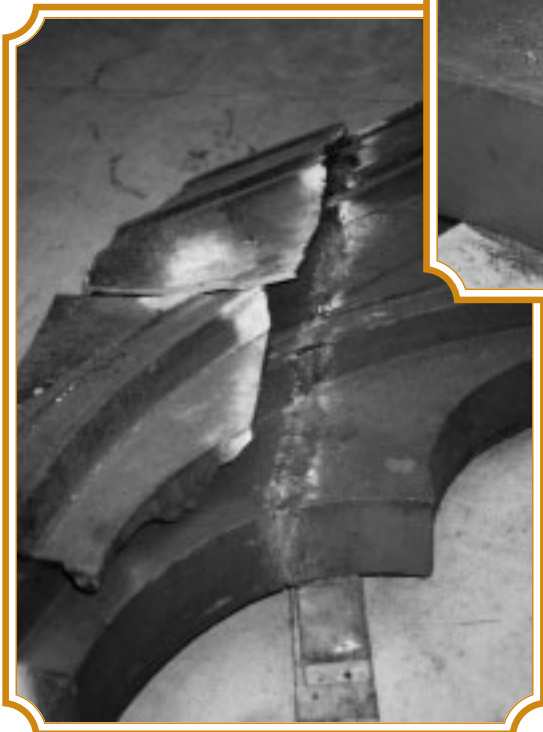
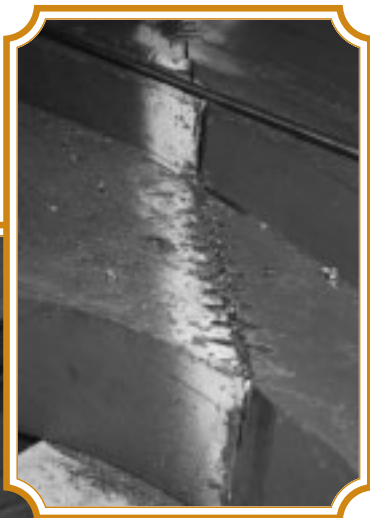
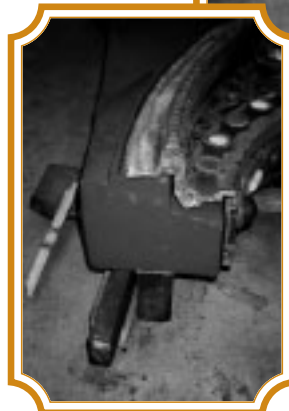
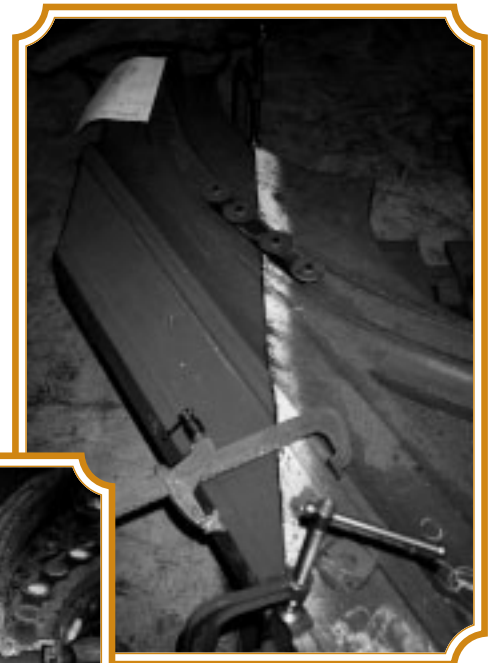
• ALBERT MEMORIAL •

Metalock Engineering UK Ltd were asked to repair London's Albert Memorial.

Upon completion of a thorough inspection it was decided to retain as much of the original castings as possible with Metalock cutting away major damage and supplying new sections, these were then secured into position using the Metalock cold repair process.

In excess of 100 metres was repaired using the Metalock process.

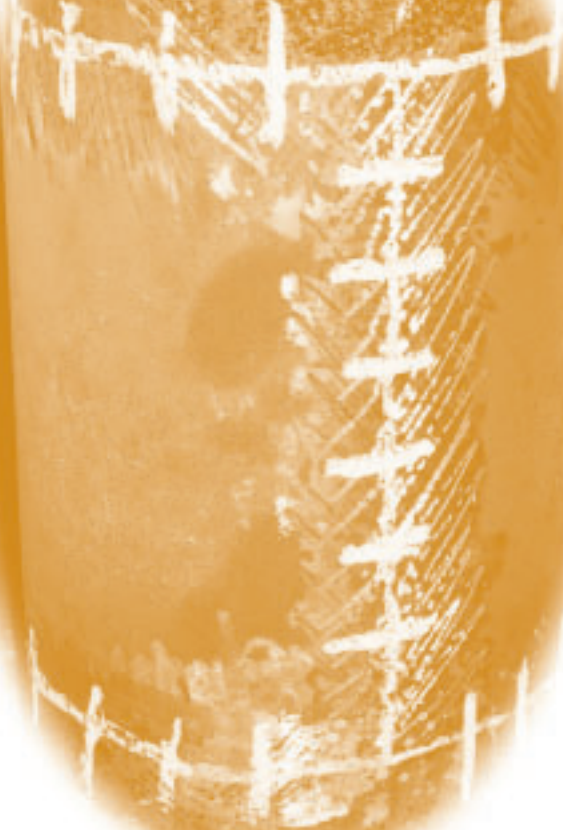
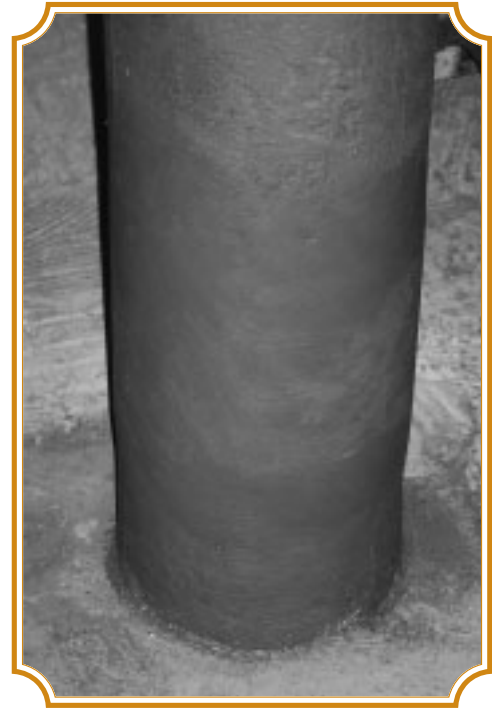
• SUPPORT COLUMN •

Metallock repairs carried out to the base of a Support Column without the costly need to remove the Column.

A new section was cast and split in two halves. A section was cut out of the column to match one of the halves, the new section was inserted and secured by the Metallock process, the remaining section was removed and replaced with the second new section and finally secured into position.

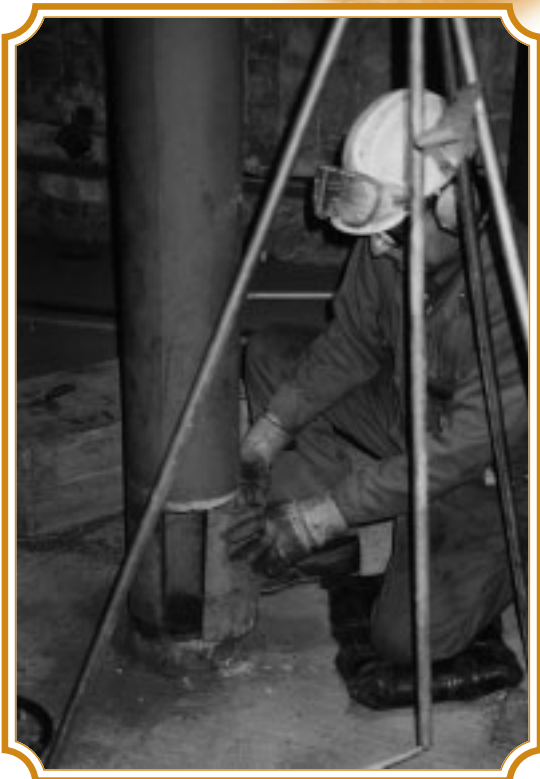
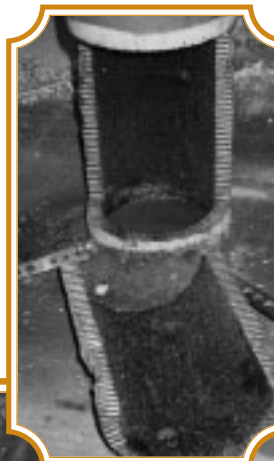
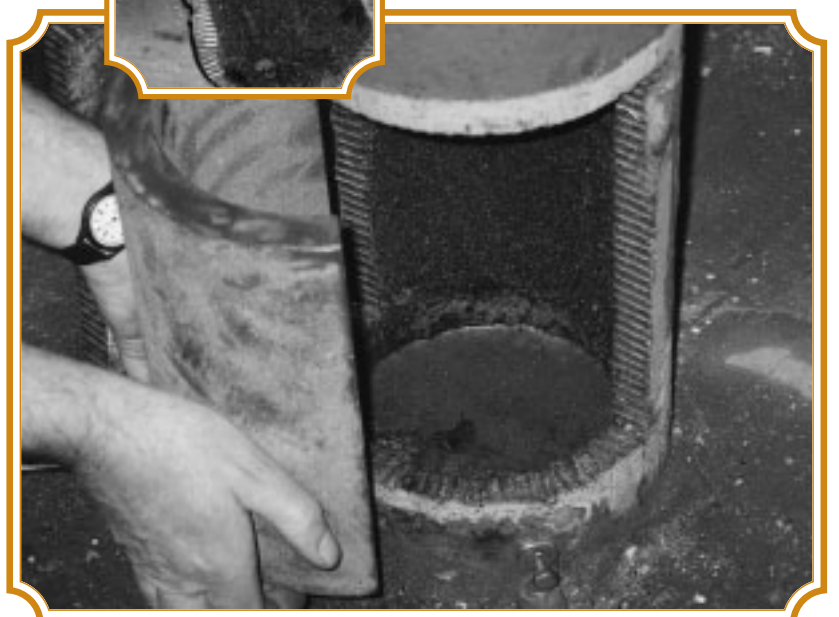
• RAILWAY PLATFORM SUPPORT COLUMN •

Railway platform Support Column fractures due to frost and repaired on-site by Metalock Engineering UK.

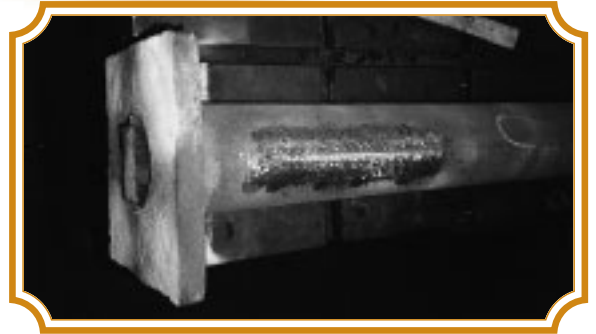
• OLD WEST BRIDGE ~ LEICESTER •

Metallock Engineering UK has used its cold repair expertise to repair and refurbish parapet panels, copings and cornices on the Old West Bridge in Leicester.

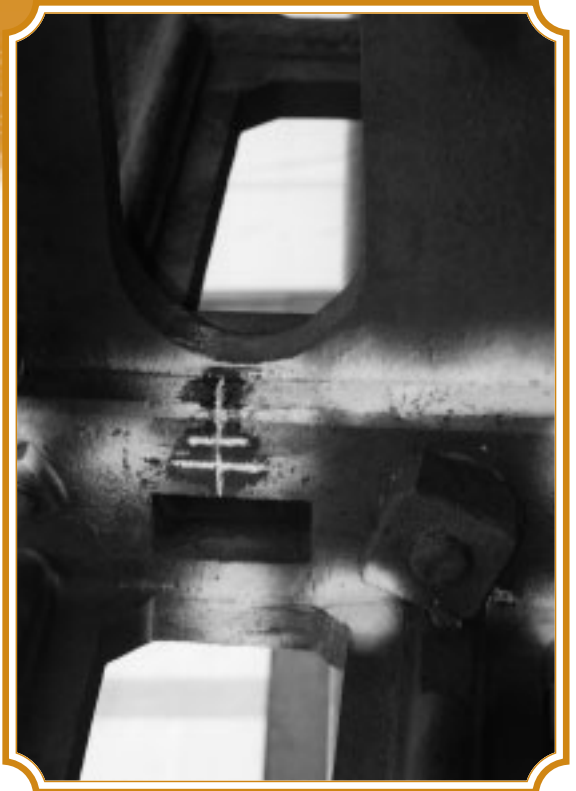
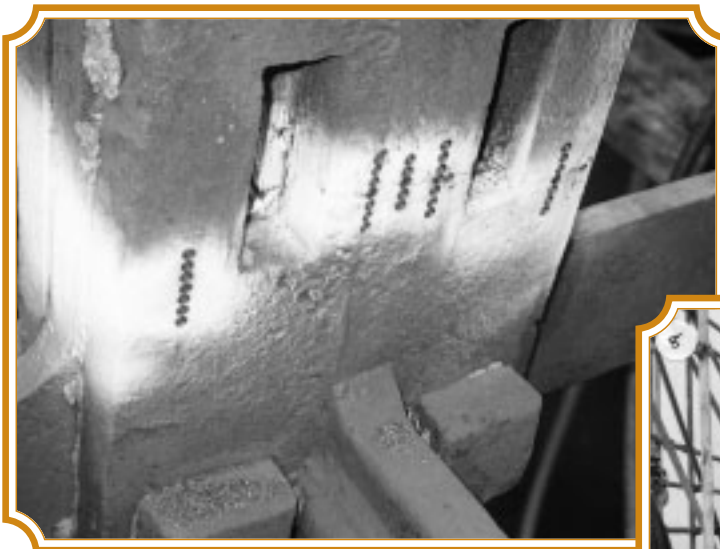
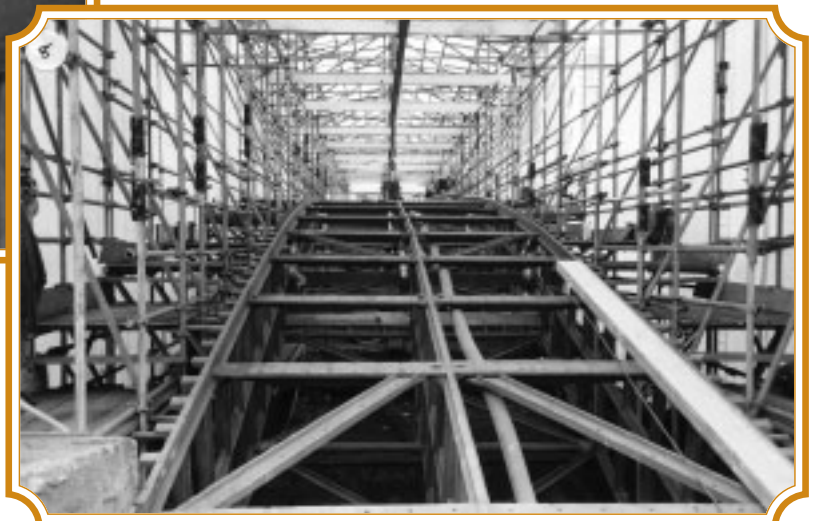
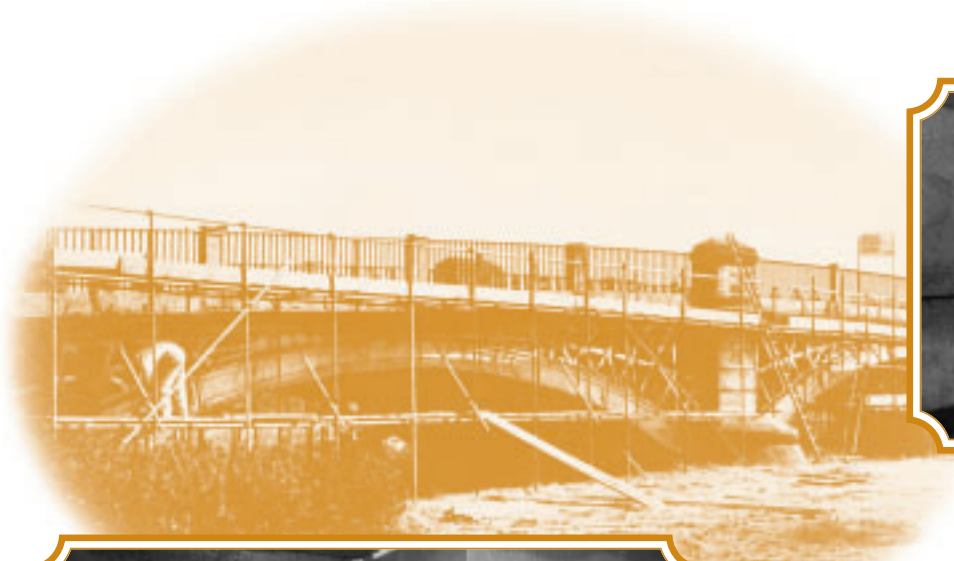
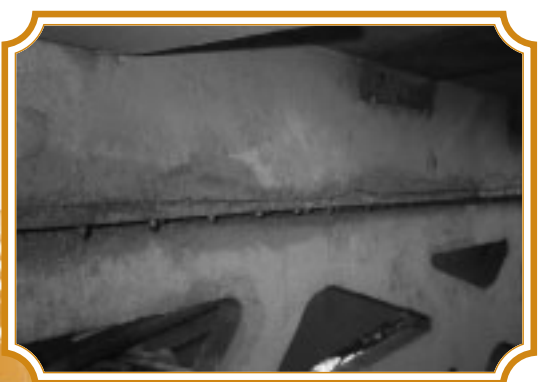
• CHETWYND BRIDGE ~ 1998 •

Following an assessment by Metalock engineers of a grade 11 Star listed cast iron bridge that had developed fractures, it was decided that the company's cold repair process could provide an effective and long lasting repair.

Seventy four metres of cracks were repaired without dismantling the bridge, taking three months to complete.

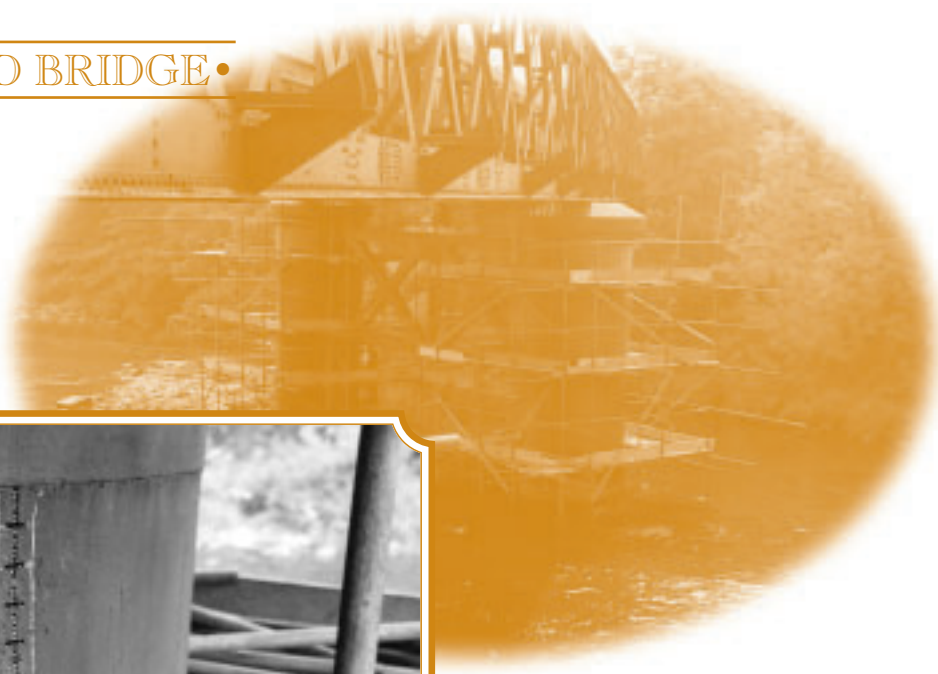
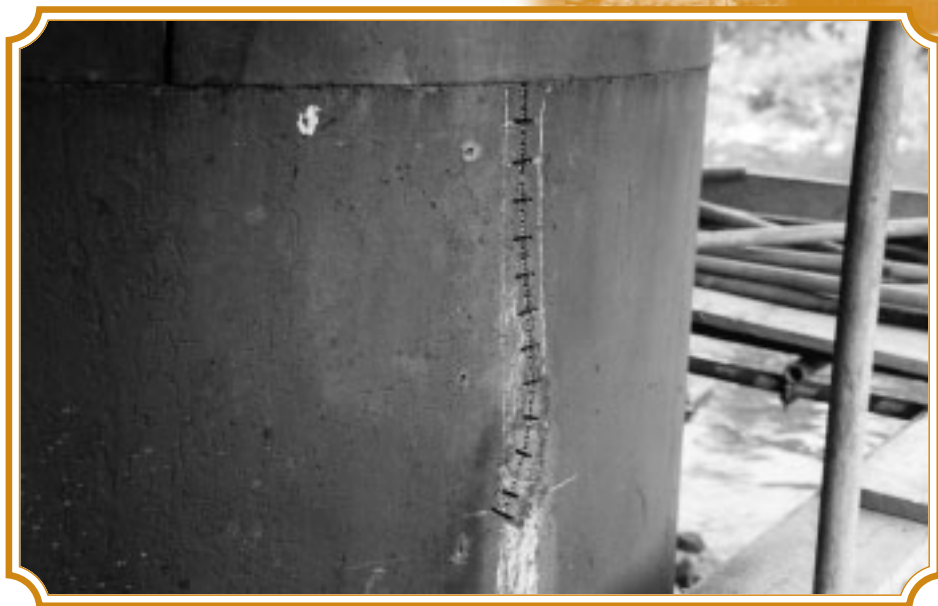
• GAS STREET BRIDGE ~ BIRMINGHAM •

The scourge of low cast iron bridges are high sided vehicles coming into contact with the structures, causing major damage. Metalock are able to replace these areas with new sections secured into position by the cold repair process.

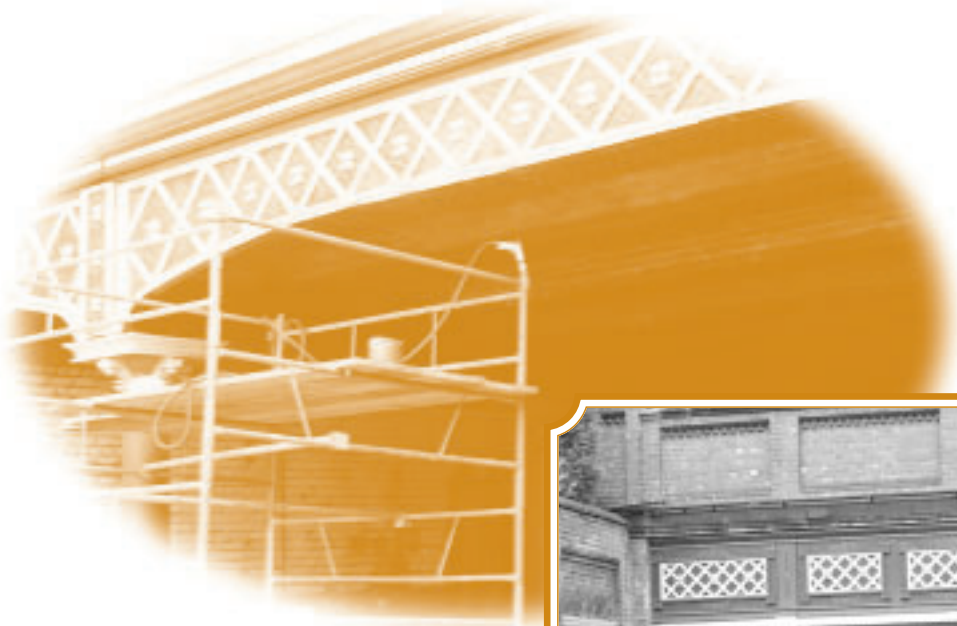
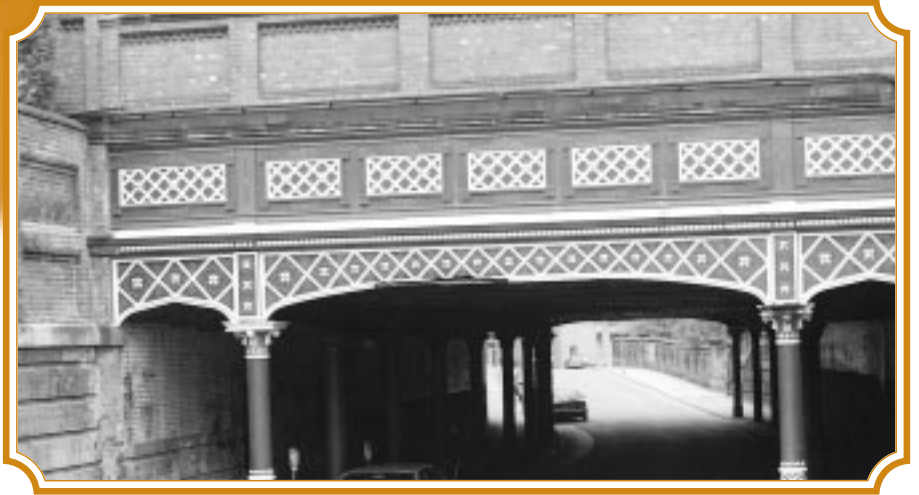
• CODSALL RAILWAY BRIDGE •

Broken cast iron lips that hold parapet panels in place on a grade 11 listed railway bridge at Codsall in South Staffordshire have been repaired by Metalock Engineering.

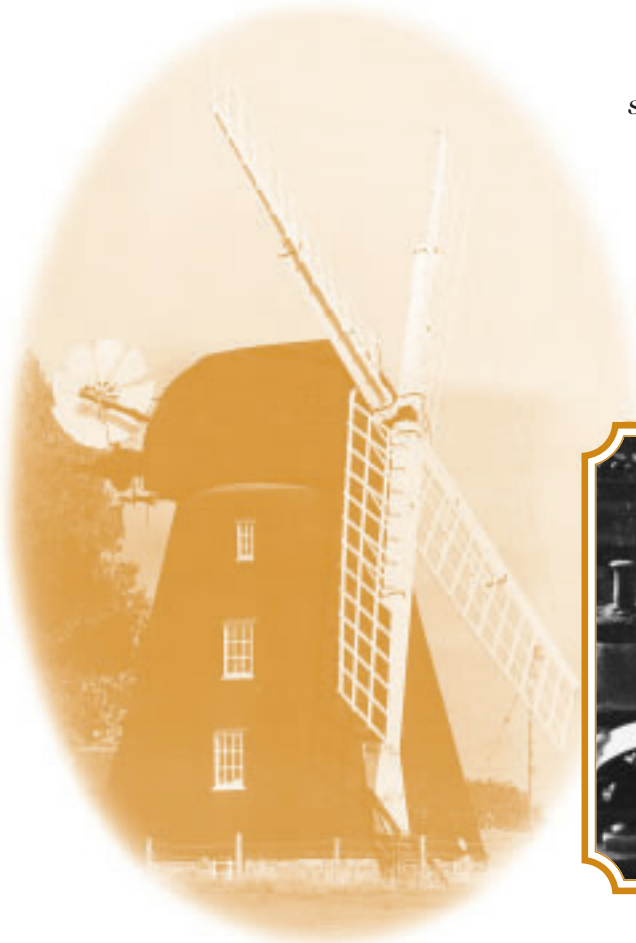
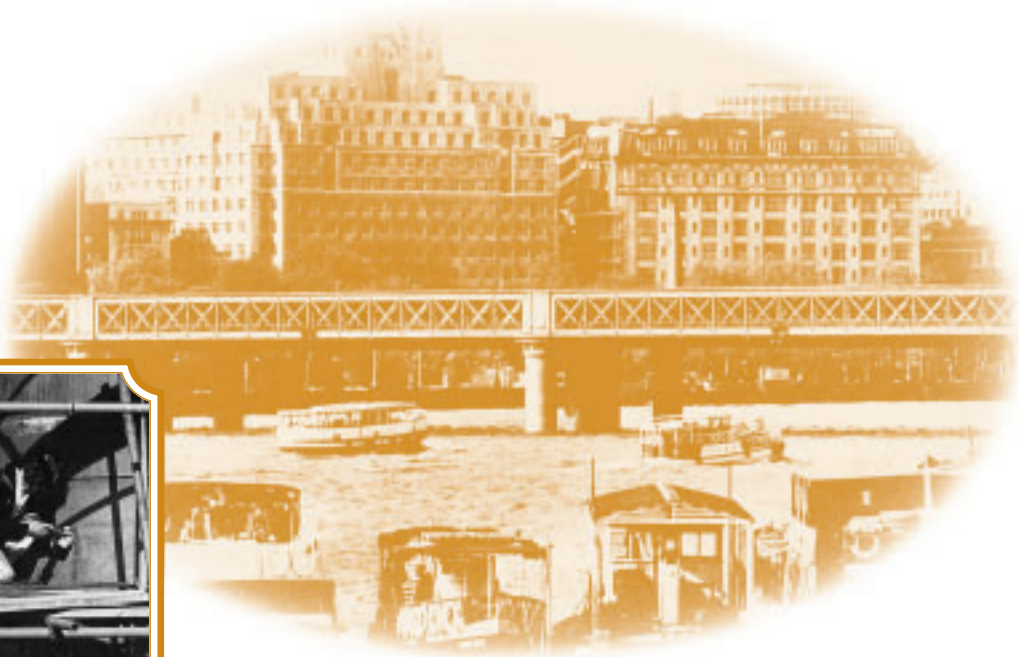
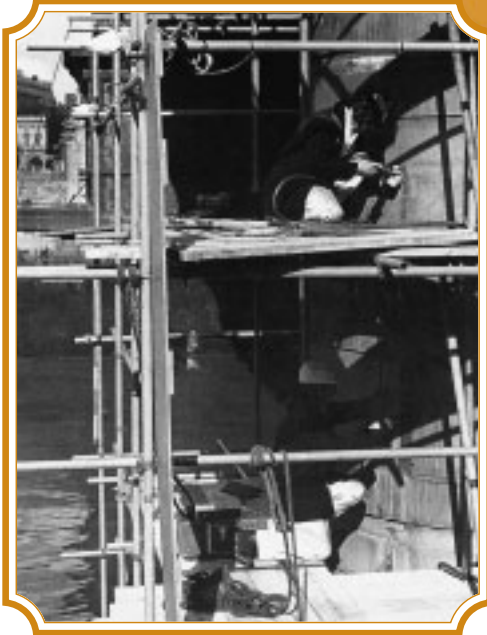
• CHARING CROSS BRIDGE •

A famous landmark in Central London, the 100 year old Charing Cross Bridge carries 123,000 commuters across the Thames by rail each day. 720 feet of cracks to the structure's sixteen cast iron columns were successfully repaired by the Metalock process with 108,000 drillings and 36,000 tappings performed on site - without disruption to rail services.

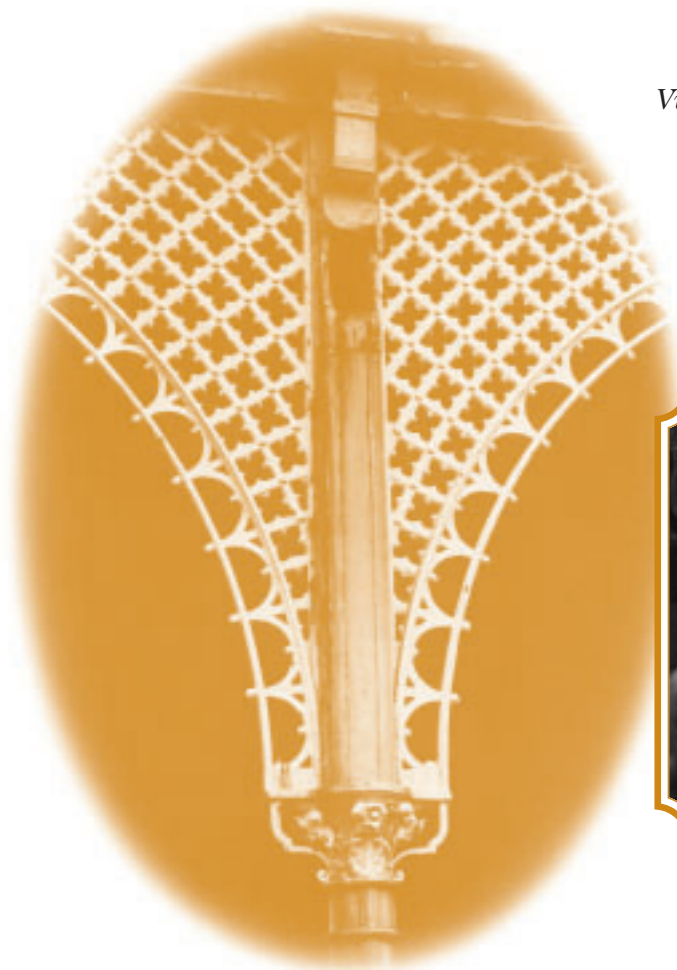
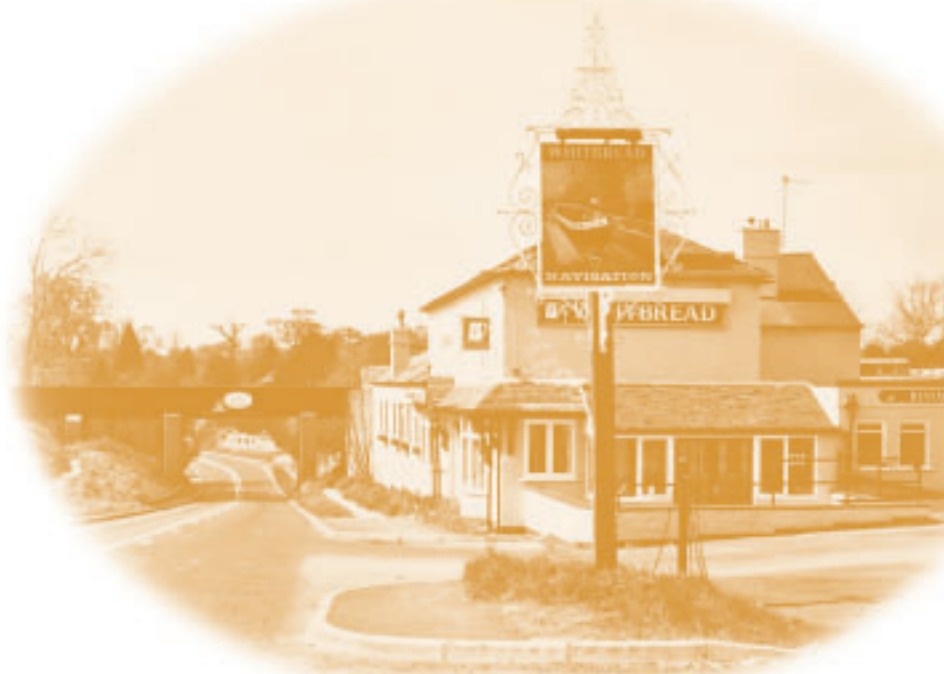
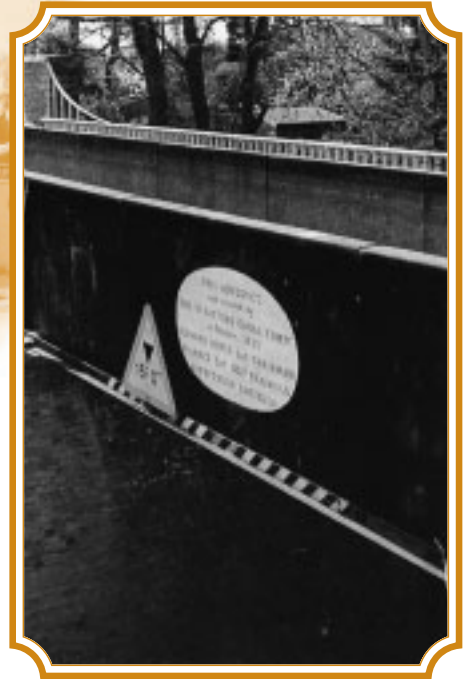
• WOOTTON WAWEN AQUEDUCT •

Built 166 years ago, the Aqueduct at Wootton Wawen was damaged by a heavy road vehicle, causing a 3 foot fracture in a cast iron tray. As it carried the busy A34 road from Birmingham time was of the essence. The watertight repair was successfully completed in four days with minimum disruption to road and canal traffic.

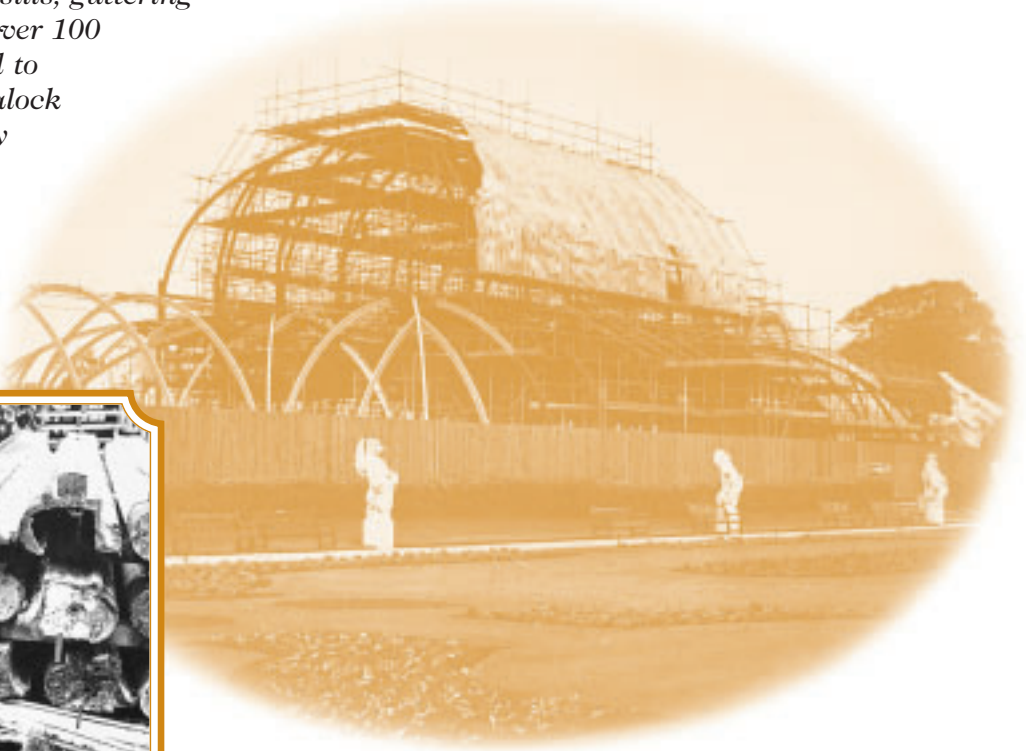
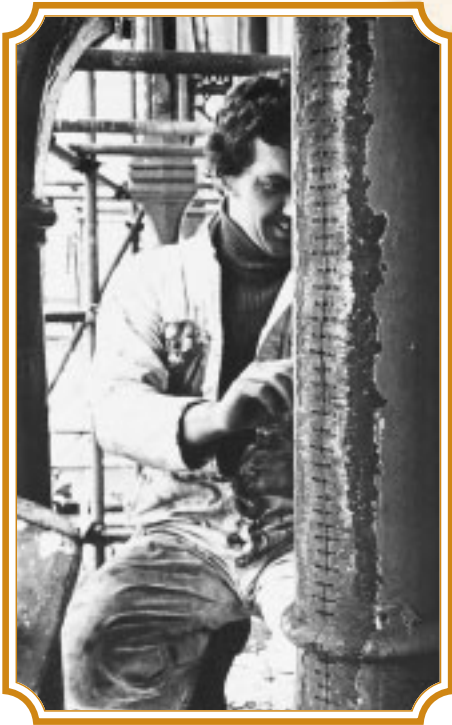
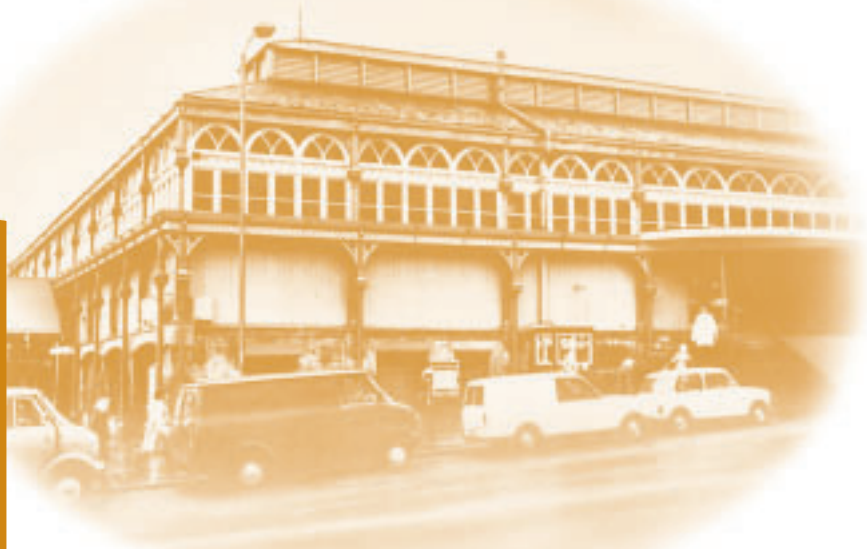
• DARLINGTON MARKET •

Restoration of this 100 year old historic covered market was carried out under a preservation order. Inspection showed 24" to 48" fractures in six of the cast iron architectural columns supporting the roof. As it was virtually impossible to replace the columns without a total stripdown, a repair was essential, avoiding the shortcomings of welding. The Metalock repair required no dismantling, was guaranteed and approved by Lloyd's.

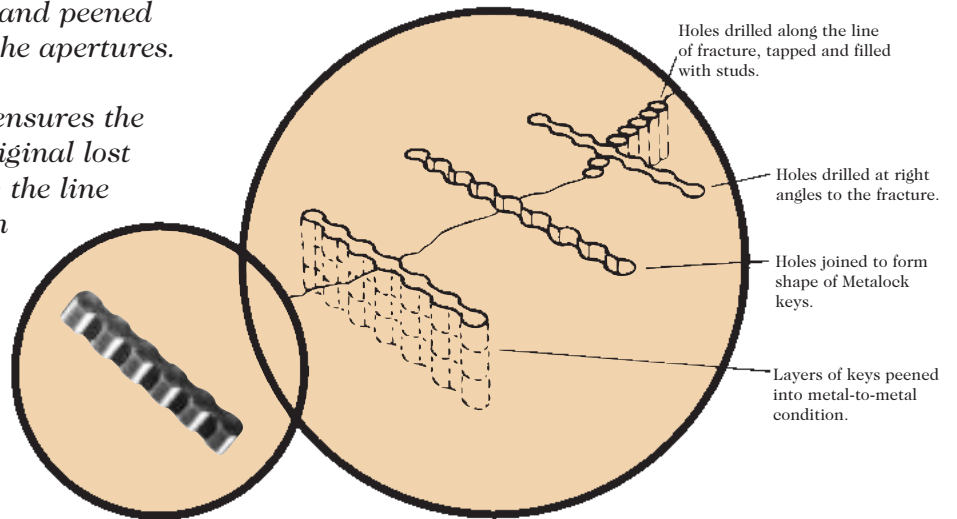
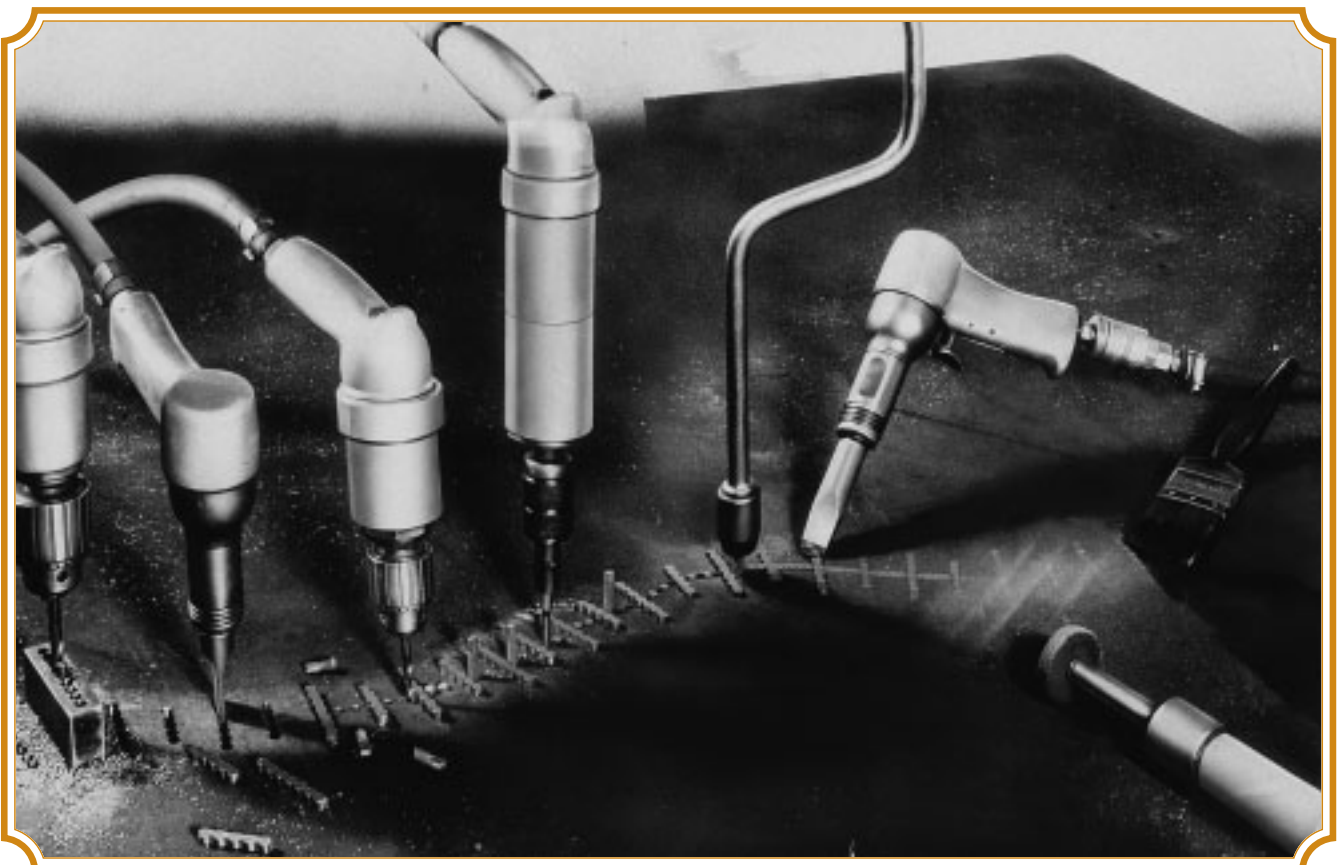
• THE PROCESS •

The Metallock repair consists of peening into prepared apertures layers of multi-dumbbell shaped keys. These keys are manufactured from a special highly ductile alloy (MN211) specifically developed by Metallock's own engineers and unobtainable outside the Metallock organisation.

A series of holes are drilled to pre-determined depths at intervals and at right angles to the fracture. The holes are then joined by the use of pneumatic chisels to take the exact female form of the Metallock keys. Metallock keys, size-matched to the holes, are inserted layer by layer and peened into a metal-to-metal condition into the apertures.

The high tensile strength of the keys ensures the return of a large percentage of the original lost strength. Holes are then drilled along the line of the fracture, tapped and filled with studs, each stud biting into its predecessor. This operation restores rigidity to the casting and ensures a pressure tight joint, essential for vessels subject to high steam or hydraulic pressures.

Hand grinders are used to finish off the repair prior to painting, and every repair is covered by the Metallock warranty.
