## Press Information

### METALLOCK PROCESS ENABLES SUCCESSFUL RESTORATION OF LONDON'S ALBERT MEMORIAL

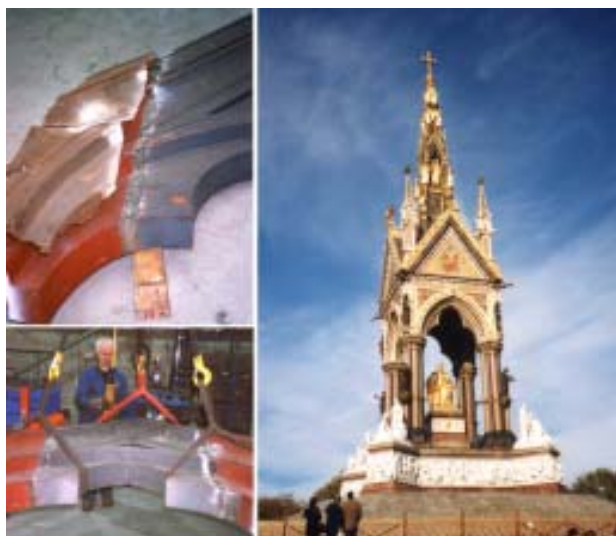
*Nearly 100 metres of "Metallocking" was used to repair broken and badly cracked core castings comprising the elements London's Albert Memorial. Pictures shows stitching new to old on one of the upper gables in Metallock's workshop.*

A system for cold repairing cracks and broken castings is the Metallock process and Coventry firm Metallock Engineering was called in by the contractors DGT Steel & Cladding early in the restoration programme to assess whether the process could be successfully used to repair the damaged castings and provide the 60-year life required.

The answer was positive and by the time the programme was completed Metallock had carried out nearly 100 metres of cold repairs and metal stitching of new and old castings. Additionally, there was a considerable amount of fusion welding work which the company also undertakes.

The Metallock process is accepted as the method of repairing cracked and broken castings across a wide range of industries in a multitude of applications. The process is carried out either in situ or in one of Metallock's workshops. It is an entirely heat-free process and the combination of keys and studs produces a pressure-tight repair which is completed by a final peening and dressing. Components were transferred to Metallock's workshop to facilitate efficient repairs.

Following casting repairs, all components were cleaned and red lead painted before the lead claddings were put back with improved slip joints enabling expansion and contraction without causing splits.
