Press Information

METALOCK CLAIMS A WORLD FIRST WITH PF MILL GIRTH RING REPAIR FOR POWERGEN/COTTAM

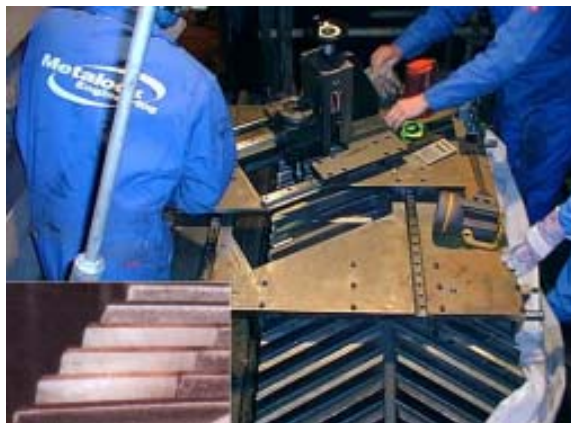
The girth ring is the main driven element used to rotate the PF mill and is a double helical gear 4.45m diameter with 174 teeth. 3 cracked teeth were replaced by Metallock in what is thought to be a world first.

The Cottam plant team called in Metallock to evaluate the possibility of repairing the cast steel girth ring by machining out the three cracked teeth and replacing them with a matching insert. Although it was believed that such a repair on a double helical gear of this type and size had not been attempted by anybody before, Metallock engineers were confident that they could achieve an effective result. They set about designing a rig to mill out the offending section. In practice, the leading and trailing faces were dovetailed to retain the new insert. Meanwhile, a new 45t/in² UTS steel insert was made with the three teeth, cut on a five-axis milling machine to achieve the lead, and a male dovetail to provide a tight clearance fit of 0.0015/0.002 inches (0.037/0.050 mm) and a lift value of 0.0005 inches (0.013 mm).

Once the insert was fitted, Metallock stitched along its base interface 130mm deep from the gear edge and at the inner edge in the tooth clearance curve area. Additionally, the two dovetail interfaces were drilled and tapped to accept studs fitted along their length to completely lock the insert into position.

These studs were subsequently machined flush. As the existing gear teeth had up to 2mm of drive face wear, those on the new insert were milled and fitted to match.
