Press Information

METALLOCK KILN TYRE GRINDING RESTORATION PROCESS ELIMINATES CRACKS RISK FOR IMERY'S MINERALS

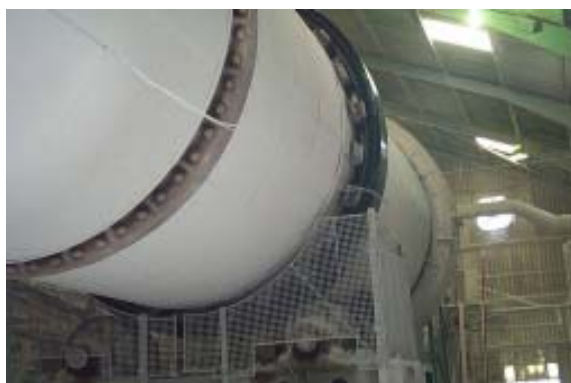
Metallock Engineering in-situ machined two 4-metre diameter, 300mm wide china clay drying kiln tyres for Imerys Minerals to eliminate vibration caused by severe tyre wear.

Metallock Engineering who has vast experience of kiln tyre grinding undertook to regrind the most badly worn 300-mm wide 4-metre diameter steel tyre. The kiln needed to be stationary while Metallock to set up its purpose-designed equipment but as the tyre needed to be revolved to grind it normal production was resumed, thus reducing downtime to a minimum. Normally, a kiln will run continuously 24 hours a day all year round.

Although Metallock had originally planned to restore only one tyre at St Austell, such was the success that it was asked to repeat the operation on a second identical tyre on the same kiln whilst they were on the premises. Metallock was on site for five days for the set-up and dismantling and the regrinding of two tyres to clean up and restore roundness. During three of those days, production continued as normal.
